RP 21

# GUIDE TO COMMON SHIPBOARD EXPENDABLE BATHYTHERMOGRAPH (SXBT) RECORDING MALFUNCTIONS

BARRY P. BLUMENTHAL  
STEPHEN M. KRONER

AUGUST 1978  
REVISED FEBRUARY 1981

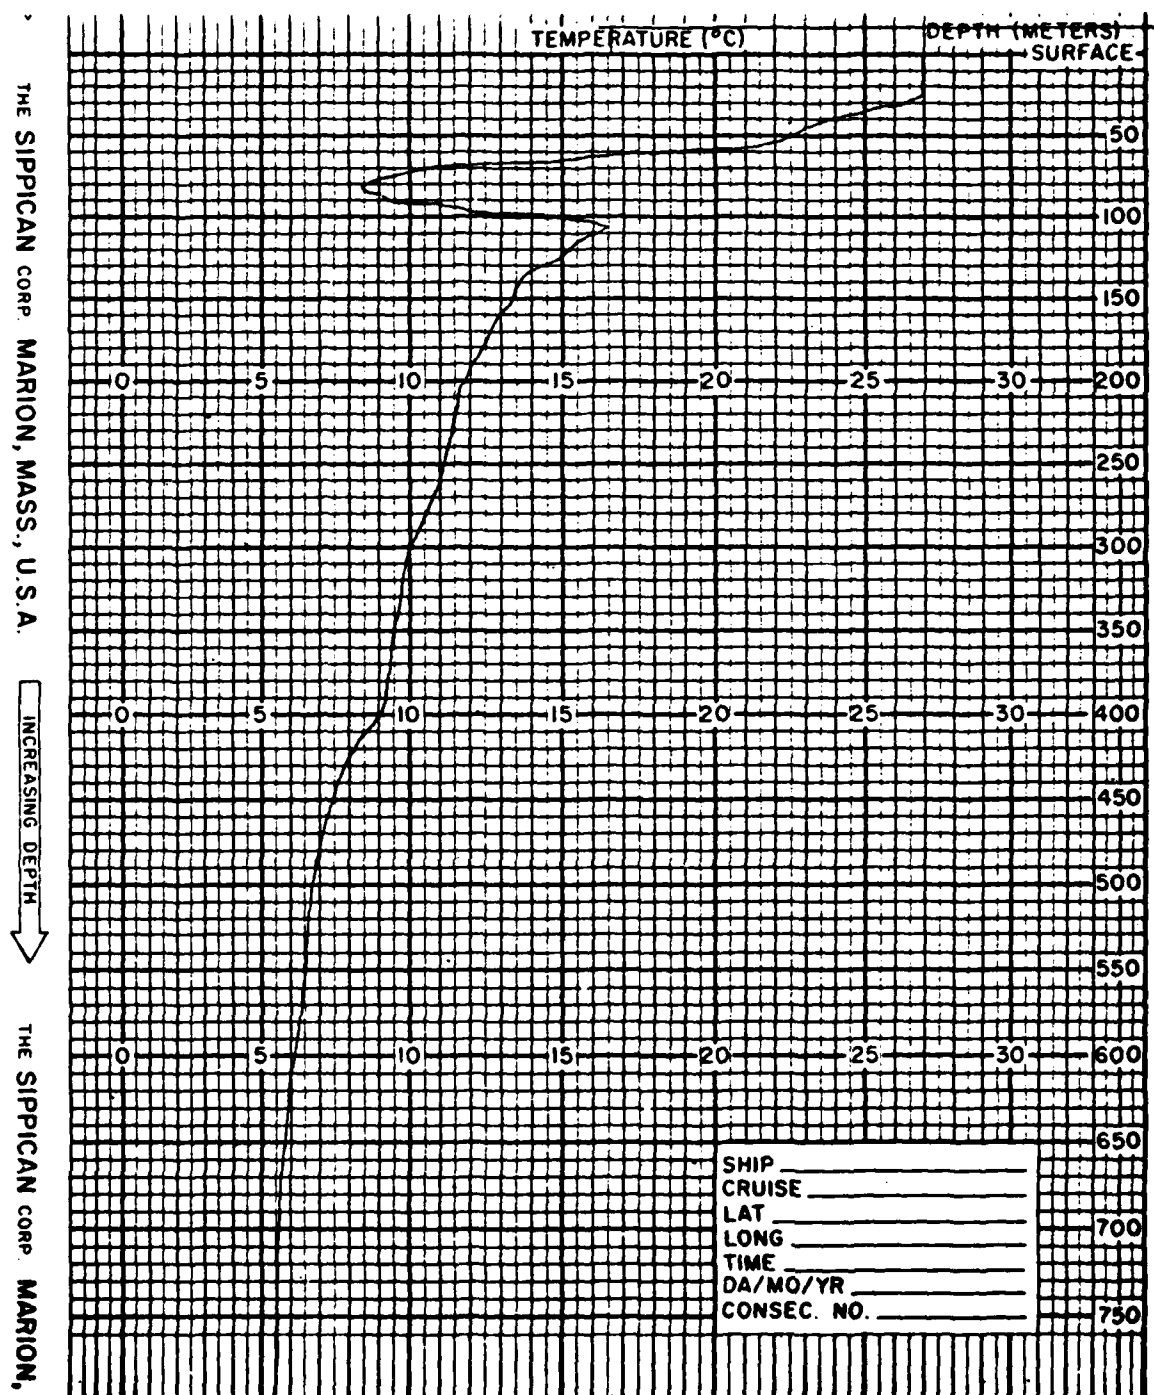
Frontal regions: Care must be exercised in determining data quality in the vicinity of oceanic fronts. Proper maintenance and calibration of the system is very important in frontal regions because the temperature structure can vary significantly between SXBT observations. The trace shown in figure 24 was obtained in the Gulf Stream. The trace exhibits a rather large ( $7^{\circ}\text{C}$ ) temperature inversion caused by entrainment of cold, relatively fresh water from coastal regions. This trace was originally labeled as questionable; however, a nearby SXBT (figure 25) also shows a temperature inversion. These temperature inversions are real. Higher-than-normal probe failure rates should be expected near major oceanic fronts because of increased current shear and turbulence.

Figure 24 - Frontal region with real 7°C temperature inversion

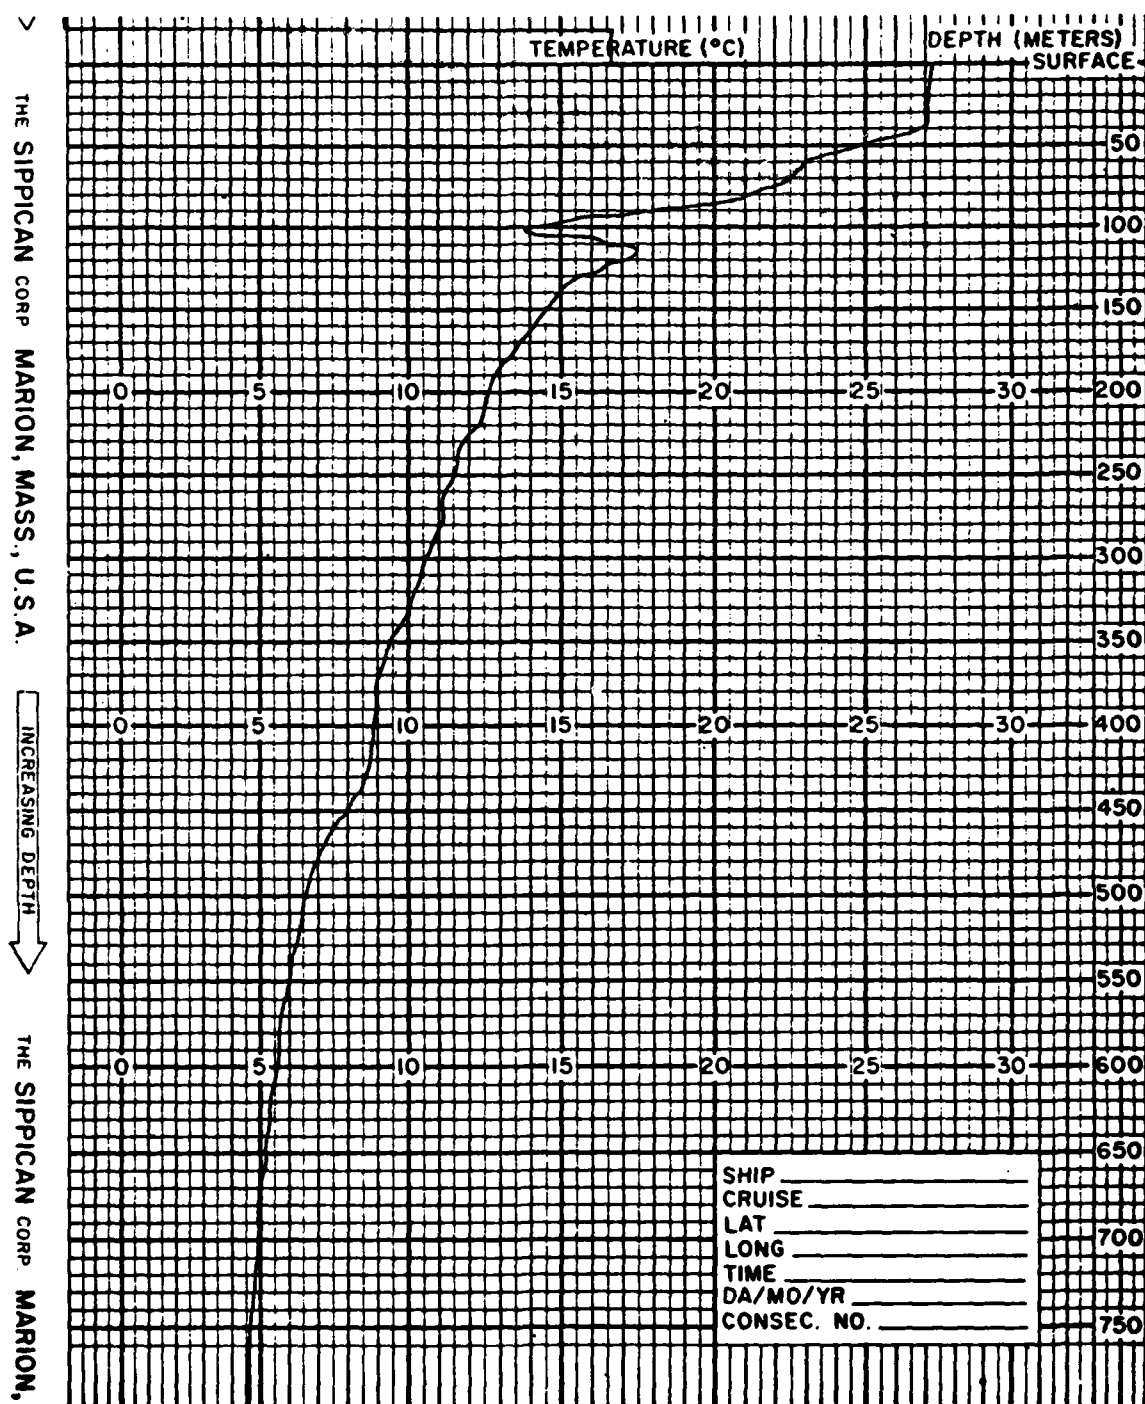
Figure 25 - Frontal region with real 3°C temperature inversion
